O9G VW Case
 Bushing Repair
 (2003 and up)

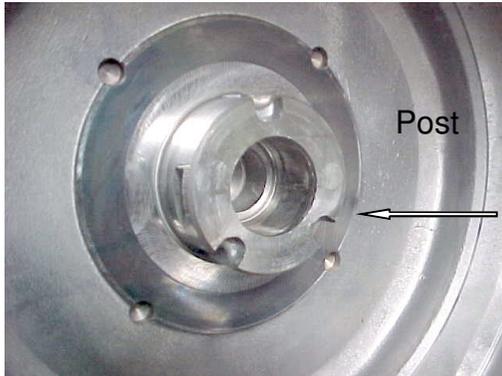
Problem: This post supports a sealing ring sleeve. The center of the post holds a bushing that tends to ruin the case when it fails. Getting the bushing out is difficult.

Omega is supplying an oversize bushing to replace the stock bushing. This is part number 90448A.

If the case fit is bad, follow the instructions below. If the sealing ring sleeve is loose, fix that first.
