The direct drum from the 5L40E has two bushings in the support tube. Both bushings are the same I.D., but different O.D. The smaller one, 98409-1 has a single identification ring on the outside of the bushing and is **must** be installed first. The two ring bushing is installed last.

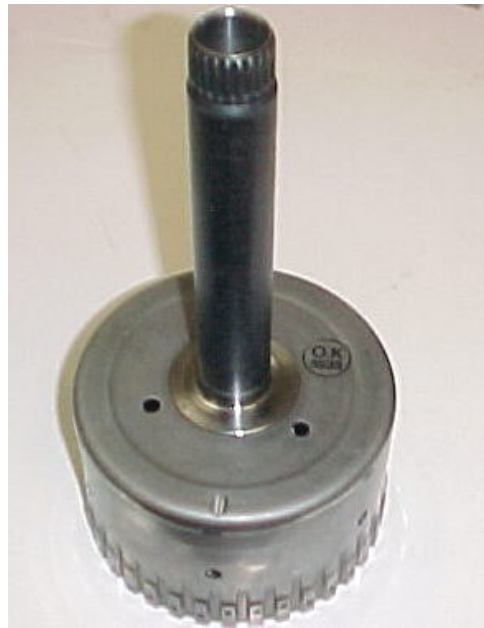
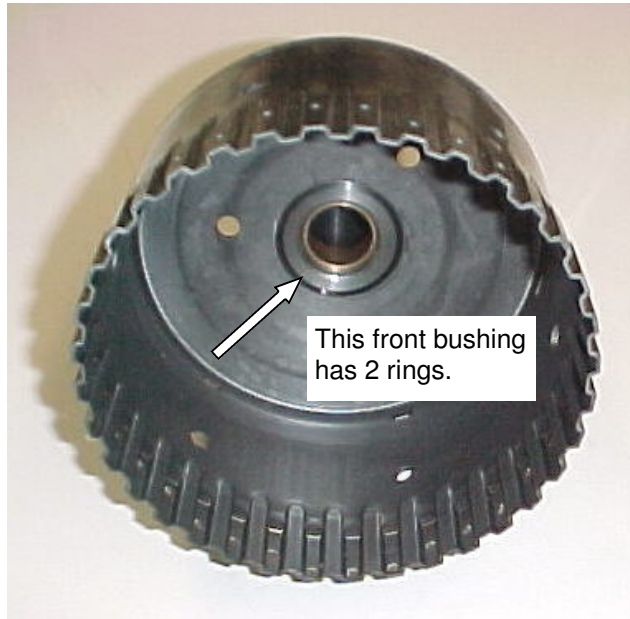
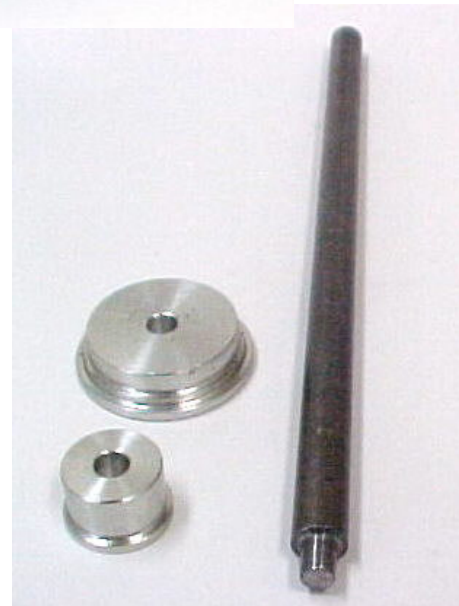
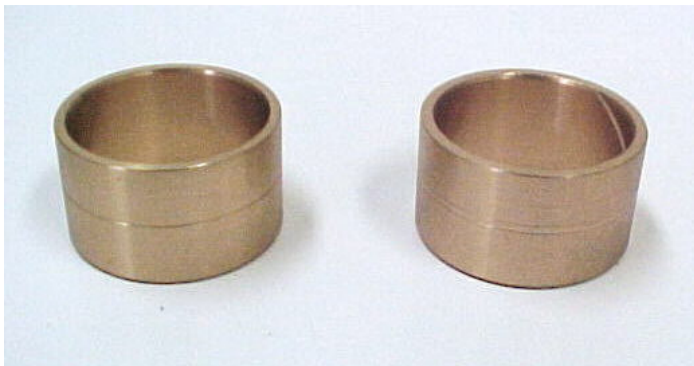
**THESE BUSHINGS WILL NOT INTERCHANGE.**

**Do not attempt to remove a bronze bushing and re-install it. The bushing will compress at installation and will fail if removed and reinserted.**
