This planetary unit from a AW-5550-SN has a common flaw. The bushing closest to the sun gear is poorly supported and likes to spin in the cage.

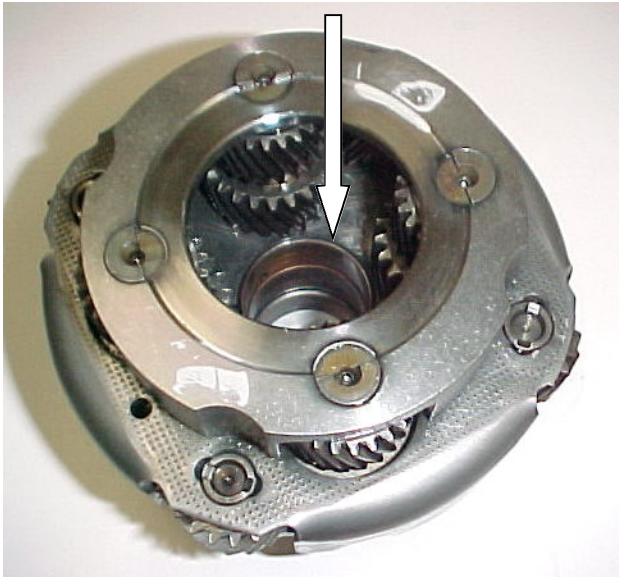
It ruins the cage destroying the bushing fit.

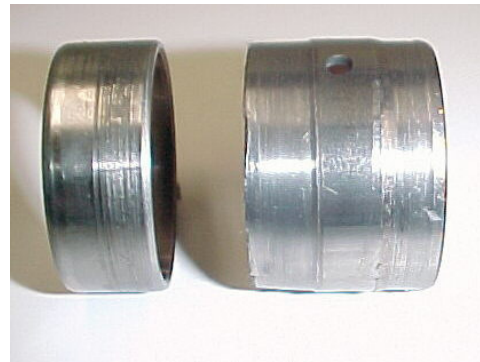
All is not lost. We bore out the cage to clean up the wear and also remove an unmachined shoulder between the bushings.

We install a single piece bushing to replace the two bushings and it becomes a better-than-stock repair.
