09G - TF60SN Clutch Drum Bushing Case Repair Tool Part # 90330 BMW 6F21A, VW, Skoda, Seat

09G TF60SN C2 Clutch Drum Bushing Repair Tool

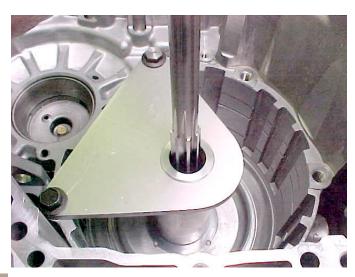
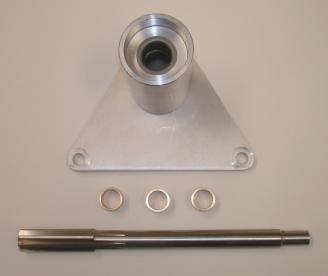
The center post at the rear of the 09G case holds a bushing that tends to ruin the case when it spins. In order to save the cases we have produced an oversize bushing.

Machining of the case is necessary to install the bushing. The sleeve at the rear of the case must fit firmly on the post. Three bushings come with the tool. Omega Machine is please to announce this tool so you can repair these cases in house.
