## 09G - TF60SN C2 Clutch Drum Bushing Case Repair Part # 90448A BMW 6F21A, VW, Skoda, Seat

## 09G TF60SN C2 Clutch Drum Bushing

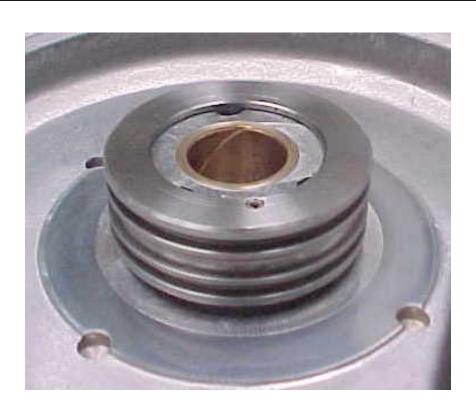
This post supports a sealing ring sleeve. Check to be sure the sleeve is tight on the post. The center of the post holds a bushing that tends to ruin the case when it spins. Getting the bushing out is difficult. In order to save the cases we have produced an oversize bushing. Machining of the case is necessary to install the bushing. We machine the cases in-house.
