Toyota Celica  
Case Repair  
(2000 and up)

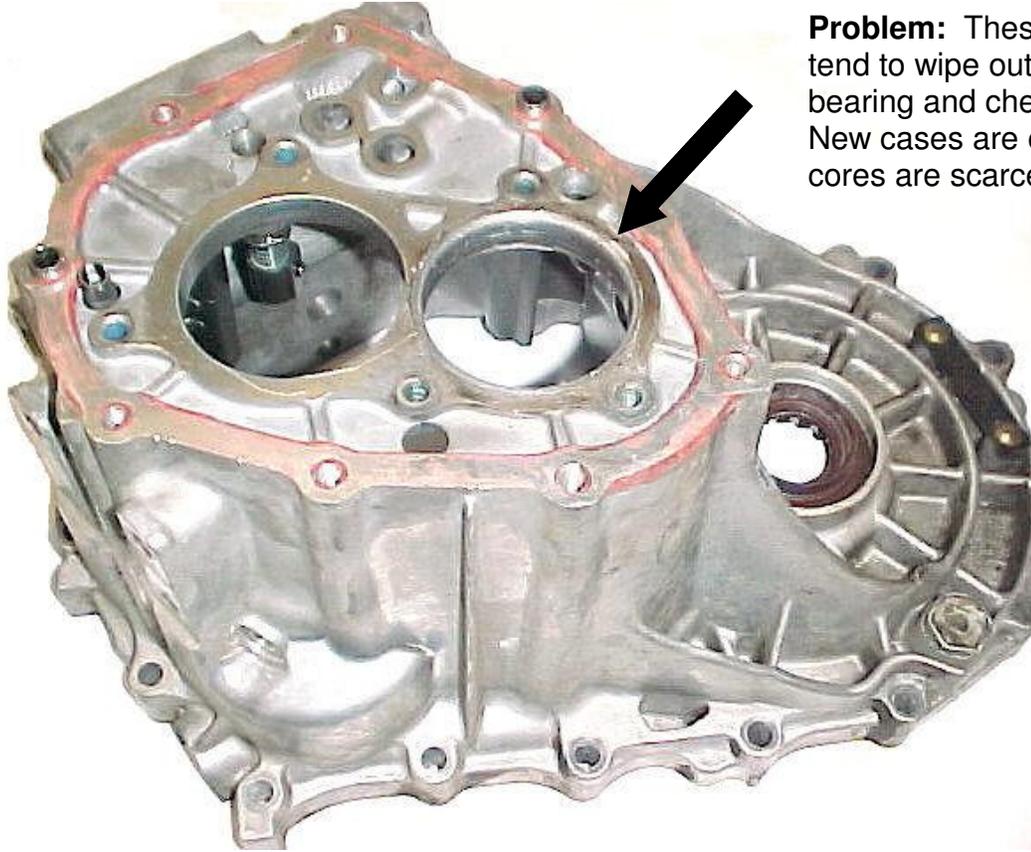
**Problem:** These Toyota cases tend to wipe out the countershaft bearing and chew up the case. New cases are expensive and cores are scarce.....
