This planetary unit from a AW-5550-SN has a common flaw. The bushing closest to the sun gear is poorly supported and likes to spin in the cage.

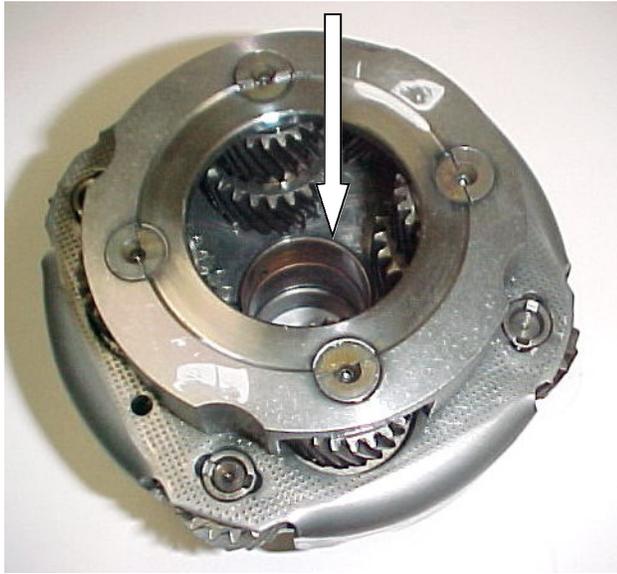
It ruins the cage destroying the bushing fit.

All is not lost. We bore out the cage to clean up the wear and also remove an unmachined shoulder between the bushings.

We install a single piece bushing to replace the two bushings and it becomes a better-than-stock repair.
