This planetary unit from a AW-5550-SN has a common flaw. The bushing closest to the sun gear is poorly supported and likes to spin in the cage.

Omega Machine & Tool, Inc.
"Precision and Innovation for Today"

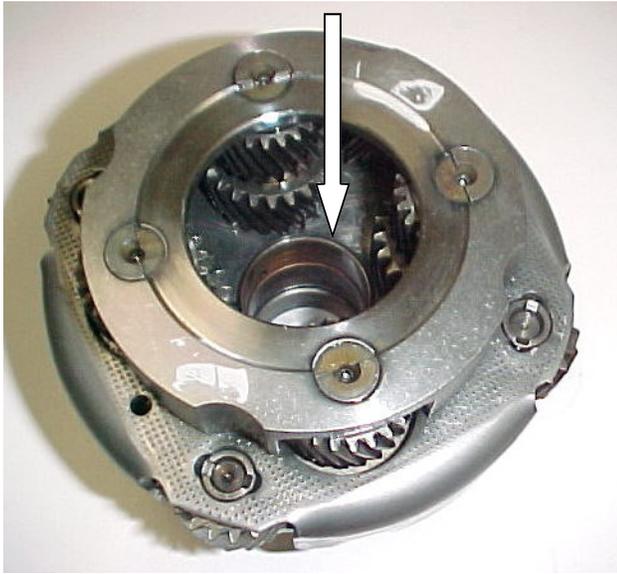
It ruins the cage destroying the bushing fit.
