42RE Extension Housing Repair

Grand Cherokee 99-04 Dodge Dakota 04-05 Chrysler 99-04

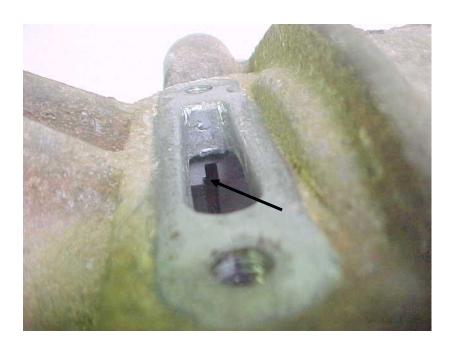
The extension housing bearing snap ring wears into the case causing the rear bearing to walk back and forth in the case.

We repair the case to take the load off the snap ring
