Toyota A246E Case Repair

A246E Vehicles

1994-1999 Celica ST, 2003-2007 Matrix, 2003-2008 Pontiac Vibe

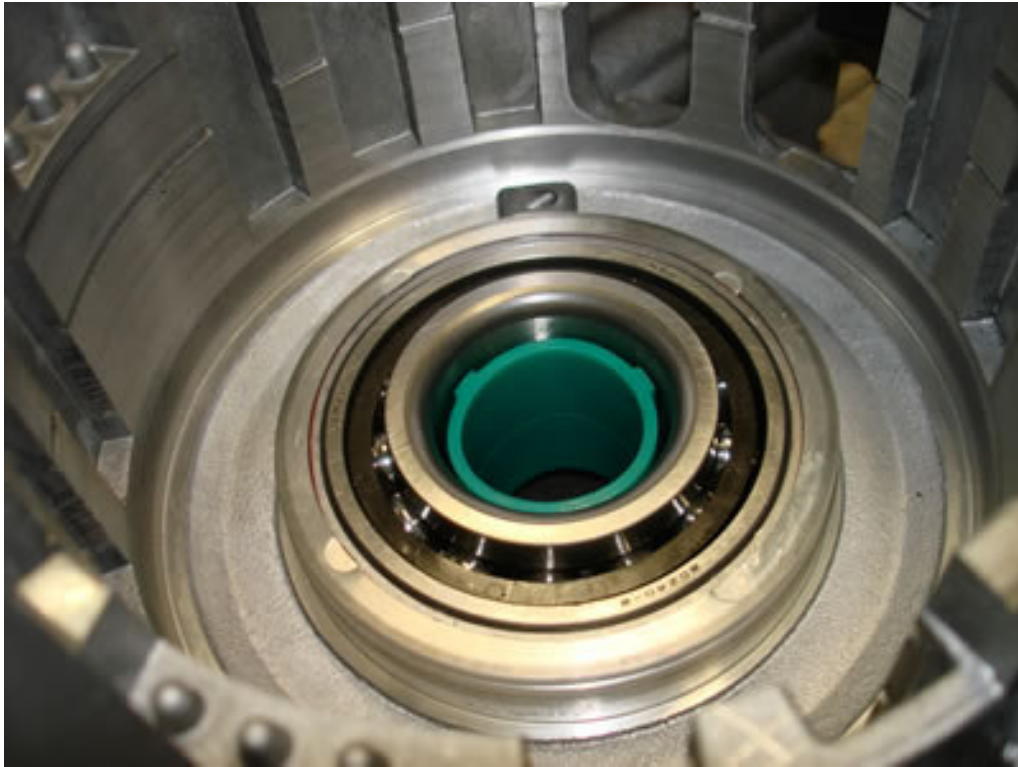
The center bearing spins in the case distributing fine metal particles throughout the transmission.
Can you say shift problems?
